# Manhole Inspection Summary

Manhole # S69U\_\_009MH

**Location** Address: **1811 Portal St.**

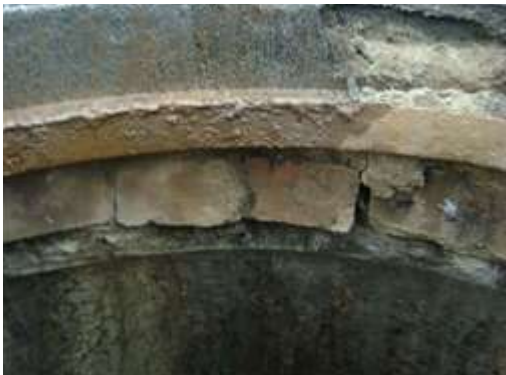
Defect 2

Condition: ☐ Sound ☐ Cracked ☐ Root Intrusion ☒ **Loose Brick** ☒ **Deteriorated**

Loose bricks at frame adjustment

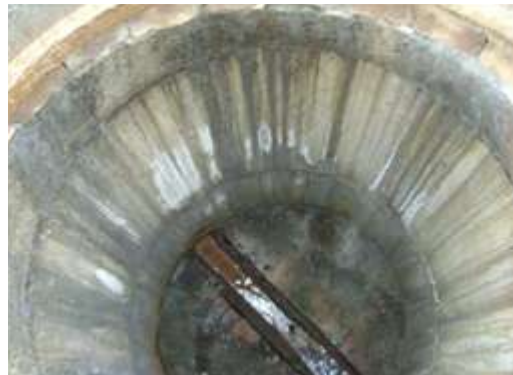
Defect 1

Infiltration: ☐ None ☐ Joint ☐ Cracks ☒ **Mortar** ☐ Roots ☐ Wall

Infiltration from frame down the walls

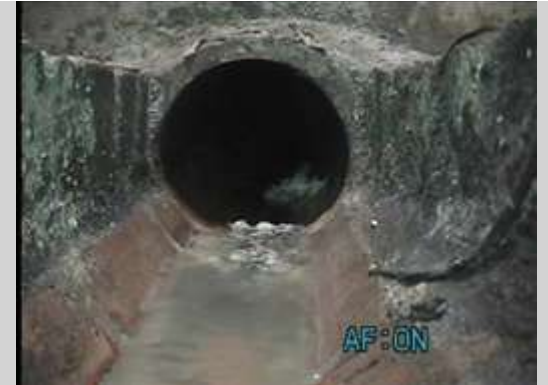
12 O'Clock Outflow

8 in. Circular Gravity Sewer  
Pipe Out @ 12 O'Clock

Pipe Height: **8.4** (in.) Rod and Bar (Angled)  
Pipe Material: **Clay** ☐ Pipe Lined  
Invert Depth: **8.17** (ft.) Flow Characteristics: **Slow**  
Deposits: ☐ None ☐ Mud ☐ Sludge ☒ **Debris** ☐ Grease  
Silt Depth: **0.5** (in.) Deposits Extent: **Light**  
Infiltration: **None** Pipe Seal Cond: **Sound**

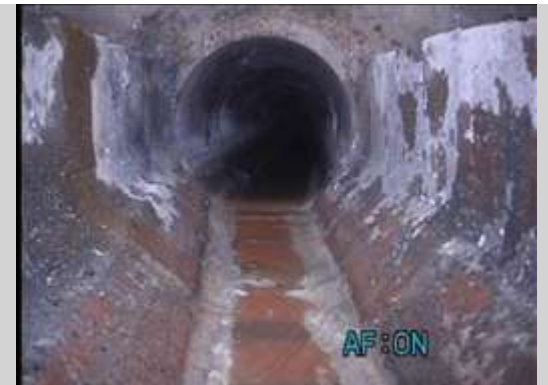
6 O'Clock Inflow

8 in. Circular Gravity Sewer  
Pipe In @ 6 O'Clock

Pipe Height: **8.4** (in.) Rod and Bar (Angled)  
Pipe Material: **Clay** ☐ Pipe Lined  
Invert Depth: **8.08** (ft.) Flow Characteristics: **Slow**  
Deposits: ☒ **None** ☐ Mud ☐ Sludge ☐ Debris ☐ Grease  
Silt Depth: (in.) Deposits Extent:  
Infiltration: **None** Pipe Seal Cond: **Sound**
